Reprinted from Journal of the New England Water Works  
Association, Vol. XIII, No. 4.

CLEANING A WATER MAIN IN ST. JOHN, N. B.

WILLIAM MURDOCH, C. E.

Engineer Water Works.

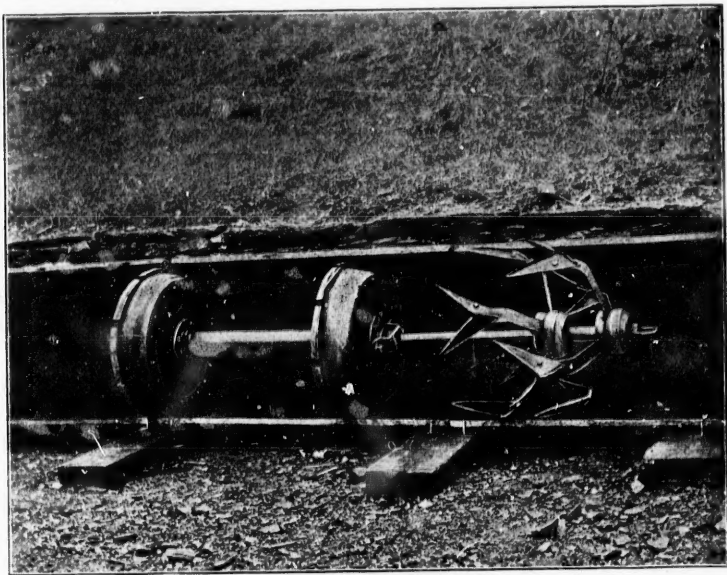
FIG. 1. FIRST SCRAPER USED.

fittings were designed and cast, and when they were placed in position the work of cleaning began. Meanwhile a scraper was designed and constructed in the workshops of the department, the pistons being of birch, built in layers crossing the grain and bolted together as shown in cut (Fig. 1). The spindle connecting the

pistons is of 3 inch wrought iron pipe, and the flanges of the ordinary kinds screwed on and rivetted to prevent backing out and falling apart when inside the pipe. Projecting beyond the forward piston is an iron rod, fitted with two sets of radial arms, four in each set, sloping back, as shown in the photograph. During the operations in the year 1897 this style of arm and cutters was used, and with this we will first deal. Each arm consisted of one layer of No. 10, B. W. G. spring steel, two inches wide, and was fitted with a forged steel fish-tail scraper made of such a form that it passed over any hard obstructions and yet reduced the incrustation considerably with each cut.

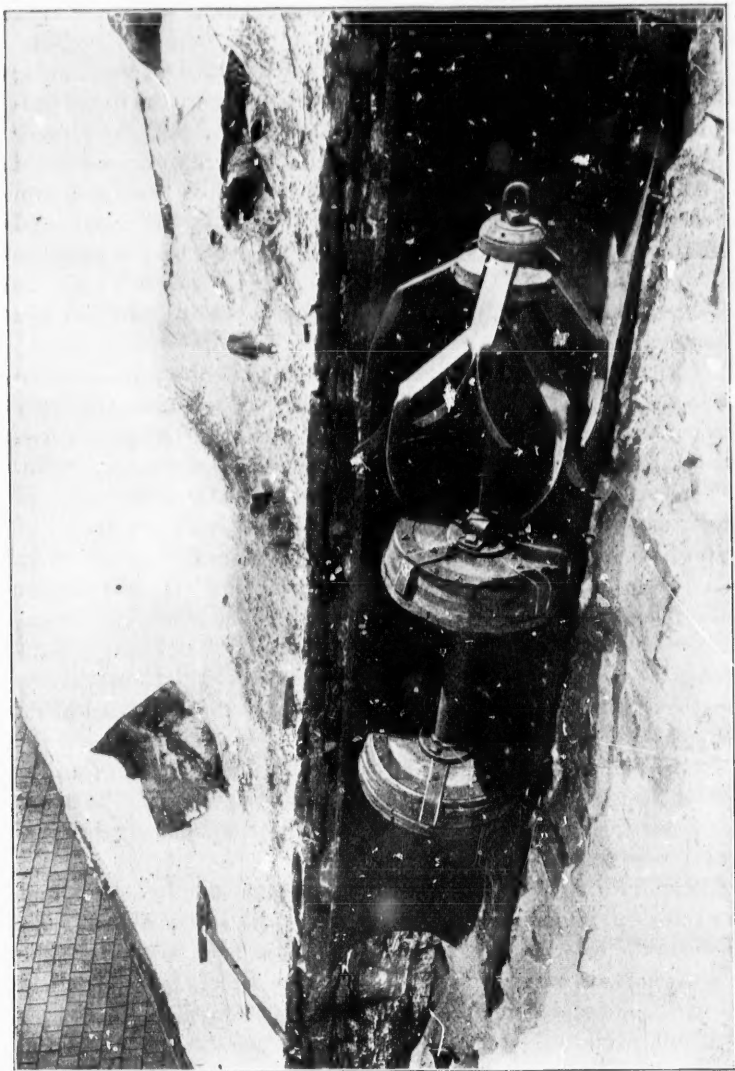
FIG. 2. IMPROVED SCRAPER USED IN 1898.

The operation was resumed last summer, the first run having been made June 9th, 1898, with the same apparatus as in the preceding season. After carefully studying the action of the cleaner and giving it several runs, it was found that an improvement could be made in the scraper, which was accordingly done, and each arm fitted with a steel cutter that would not clog. It was also found that the arms could be stiffened without any risk of the machine sticking, and this was done also. The final outcome of all the improvements was an apparatus of which the cut on page 338 is a photograph.

This scraper cut through all the deposit to the bare iron, an inspection at the termination of the work having shown that only the scars or imprints of the tubercles remained on the interior surface of the pipe, and it was almost as smooth as when first made.
